FINAL REPORT

EXECUTIVE SUMMARY

SPECIFIED FACILITY ENERGY STUDIES FOR
ENERGY ENGINEERING ANALYSIS PROGRAM (EEAP)
AT U.S. ARMY SUPPORT COMMAND,
HAWAII (USASCH) INSTALLATIONS

FT. SHAFTER
TRIPLER ARMY MEDICAL CENTER
SCHOFIELD BARRACKS

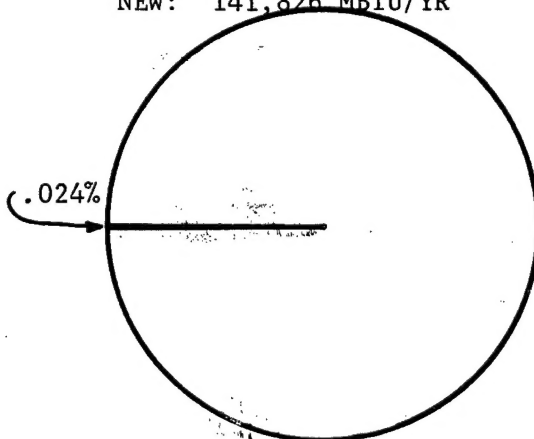
TRIPLER AMC:

NOW: 141,861 MBTU/YR

NEW: 141,826 MBTU/YR

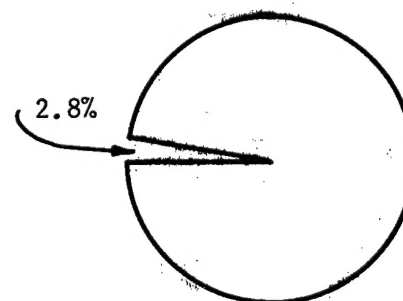
NOW: 1,246 MBTU/YR

NEW: 1,211 MBTU/YR
